Service Information

Number: VSE-20-10

Subject: T40093/5 RECALL – Inspection Needed

Date: August 7, 2020

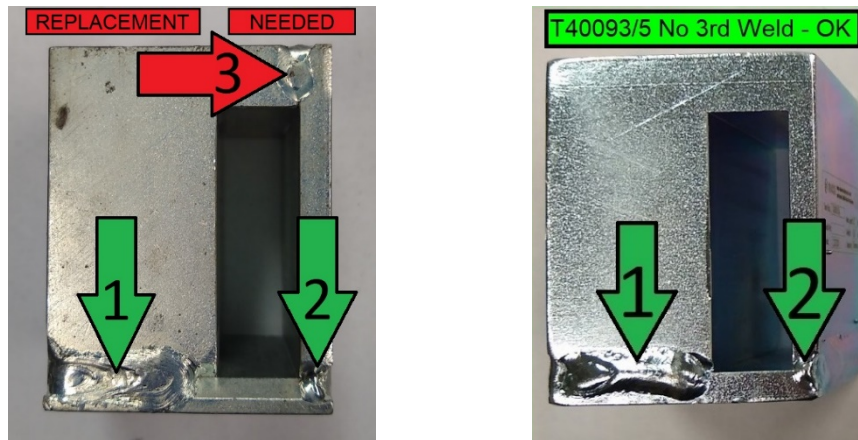
In the event of a complete malfunction of the T40093/5, the engine supported with T40093/5 will fall. Consequently, service personnel may sustain injuries and damage to the vehicle may occur. If the T40093/5 has the **third weld**, Please **DISCONTINUE USE IMMEDIATELY!** Set aside the effected T40093/5 for return and replacement.

The presence of a third weld indicates replacement is needed.

Service Tools & Equipment is in need of your assistance in locating and inspecting tool T40093/5 for a third weld. **NOTE:** you may have more than one T40093/5. Inspection of ALL T40093/5 is needed.

Please provide the requested information below and attach photos of YOUR T40093/5 whether or not it needs to be replaced.

1. Dealer Code
2. Manager/Foreman Name & DIRECT contact phone number
3. Manufacture Code
4. Number of T40093/5 that NEED REPLACED
5. Two photos of EACH T40093/5 - One Showing the **3rd WELD/Lack of 3rd weld**, and One of the **manufacture** code.

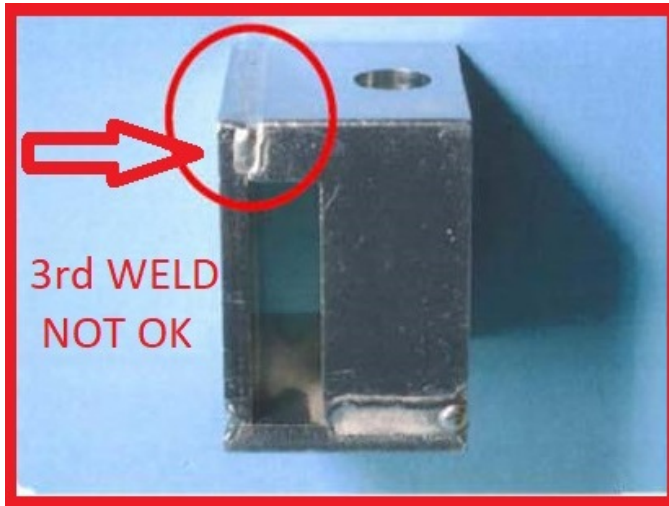
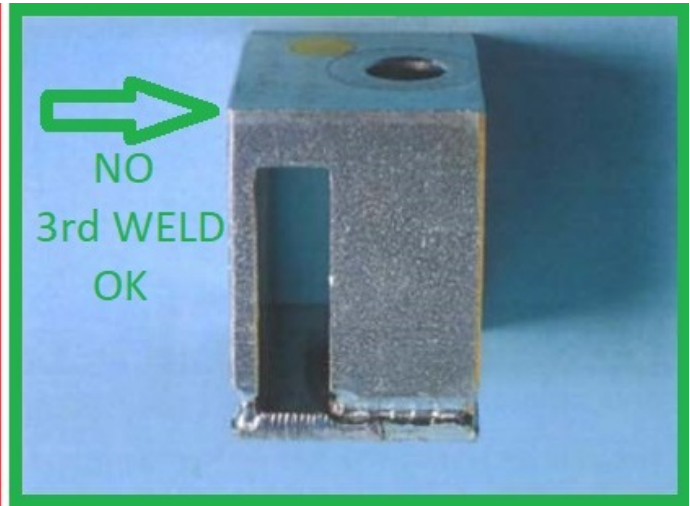
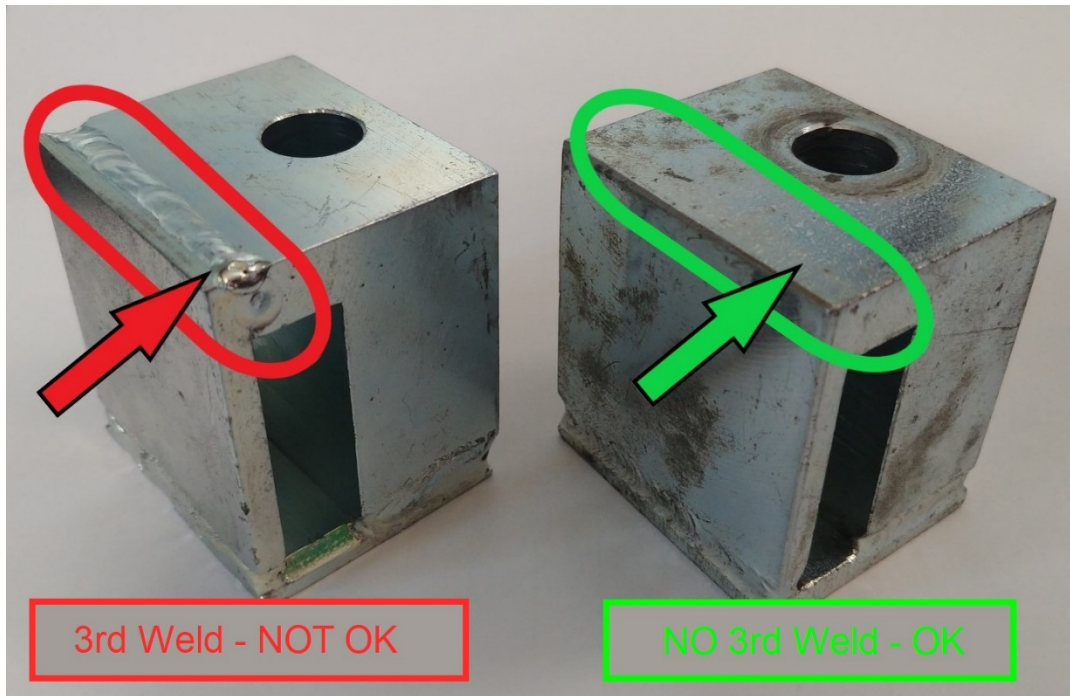
Please identify if your T40093/5 has the **third weld** as shown below, and identify as one of the following **manufactures**.

WEMA / MA

CI / MA

CE / MA

SPX / MA

Beissbarth-C49 / MA
